Slide Motor Replacement Procedure

2006 Fleetwood Discovery, Model 39S

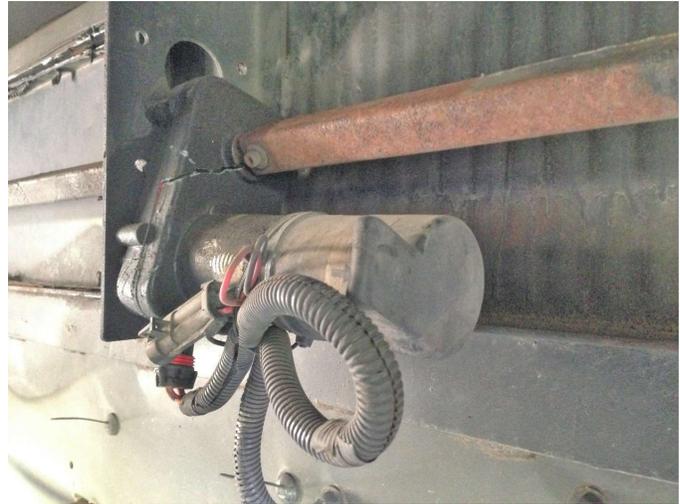
During setup after arrival at a new campground, I discovered that my driver-side slide would not extend more than an inch or so. I was able to retract it, but the same thing happened when I tried to run it out again, both times followed by a “clacking” sound similar to a ratchet slipping. I felt certain the slide motor was dead, because the same thing happened to the passenger-side slide two years earlier and the solution was to replace the motor. Calling it a motor is somewhat misleading, however, because it’s really a motor/gear box assembly. The motor may have actually been okay since it “started” running out the slide, but the gear box was totally shot as you can see from the crack in the gear box shown in this picture. Unfortunately, they are sold as a unit and cannot be purchased separately (as far as I know).

After researching on the DOAI Yahoo group, I felt like this was a project I could handle, especially since we were planning to stay at this campground for the next month and had plenty of time. So, I ordered the motor from Fleetwood for the tidy sum of \$686, including second-day delivery (*like I said, I had plenty of time, but my wife really missed the extra space*). Now \$686 sounds like a lot of money, and it is, but compared to \$1144 paid to a shop for repairing the other one ... not so bad.

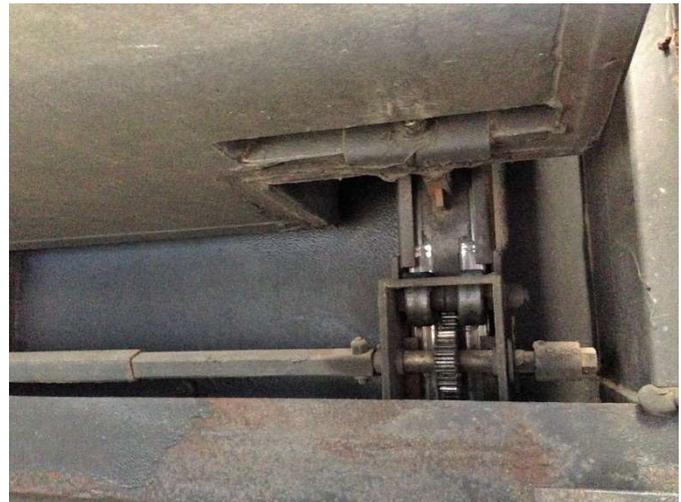
The slide has to be extended manually in order to have enough working room to replace the motor. Fortunately, Power Gear provides a pretty simple way of doing this. The motor is mounted to the chassis near the center of the slide. Long square drive rods extend from either end of the motor to the rails that carry the slide out. The far right end of the drive rod is hex-shaped, just like a hex nut. Turning hex-shaped end of the rod with a $\frac{3}{4}$ inch wrench will extend (or retract) the slide. Turn counter-clockwise to extend.

Before starting, Power Gear instructs you to locate the two-pin connector on the slide motor and disconnect it. Then, rotate the lever on the backside of the motor counter-clockwise about $\frac{1}{8}$ th turn (looking from the rear of the motor). This will release the break that holds the slide in place.
