# Slide Motor Replacement Procedure

2006 Fleetwood Discovery, Model 39S

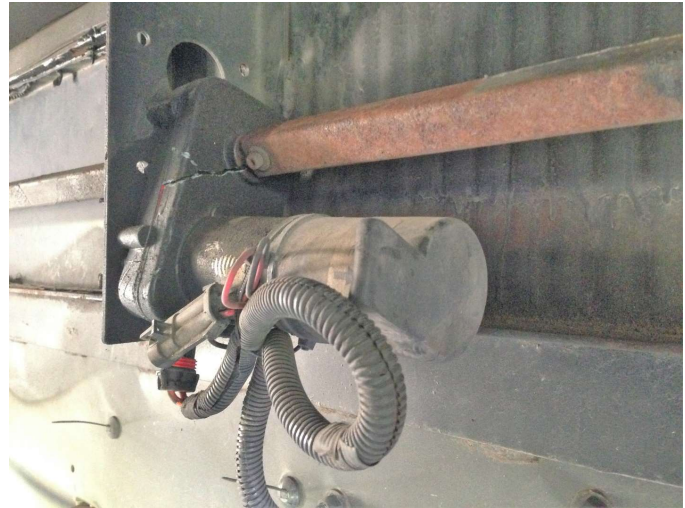
During setup after arrival at a new campground, I discovered that my driver-side slide would not extend more than an inch or so. I was able to retract it, but the same thing happened when I tried to run it out again, both times followed by a “clacking” sound similar to a ratchet slipping. I felt certain the slide motor was dead, because the same thing happened to the passenger-side slide two years earlier and the solution was to replace the motor. Calling it a motor is somewhat misleading, however, because it’s really a motor/gear box assembly. The motor may have actually been okay since it “started” running out the slide, but the gear box was totally shot as you can see from the crack in the gear box shown in this picture. Unfortunately, they are sold as a unit and cannot be purchased separately (as far as I know).

After researching on the DOAI Yahoo group, I felt like this was a project I could handle, especially since we were planning to stay at this campground for the next month and had plenty of time. So, I ordered the motor from Fleetwood for the tidy sum of \$686, including second-day delivery (*like I said, I had plenty of time, but my wife really missed the extra space*). Now \$686 sounds like a lot of money, and it is, but compared to \$1144 paid to a shop for repairing the other one ... not so bad.

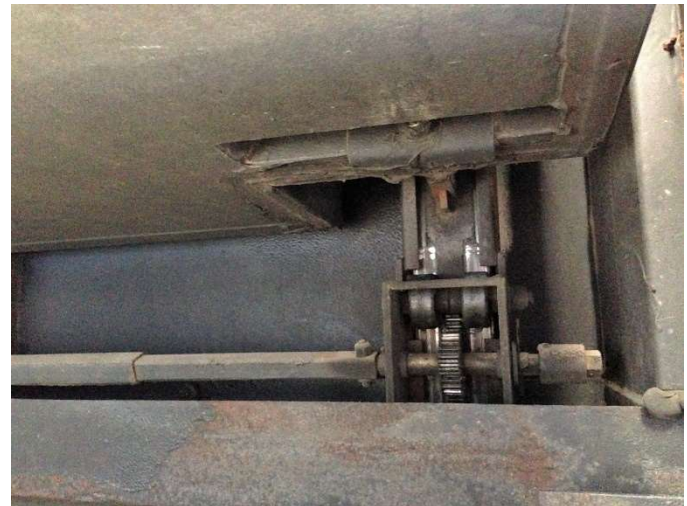
The slide has to be extended manually in order to have enough working room to replace the motor. Fortunately, Power Gear provides a pretty simple way of doing this. The motor is mounted to the chassis near the center of the slide. Long square drive rods extend from either end of the motor to the rails that carry the slide out. The far right end of the drive rod is hex-shaped, just like a hex nut. Turning hex-shaped end of the rod with a  $\frac{3}{4}$  inch wrench will extend (or retract) the slide. Turn counter-clockwise to extend.

Before starting, Power Gear instructs you to locate the two-pin connector on the slide motor and disconnect it. Then, rotate the lever on the backside of the motor counter-clockwise about  $\frac{1}{8}$ th turn (looking from the rear of the motor). This will release the break that holds the slide in place.
