Slide Motor Replacement Procedure

2006 Fleetwood Discovery, Model 39S

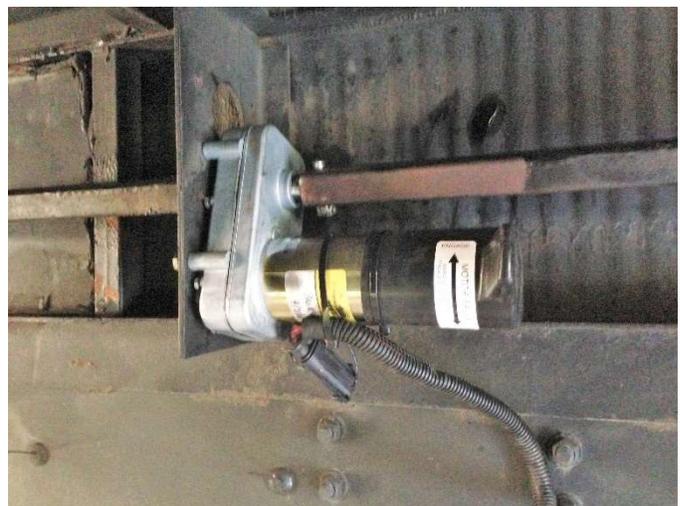
Well, that's about all there is to it. After reconnecting everything, I ran the slide in and out several times to make sure it was working okay, and it worked like a charm. The good news is I saved at least \$450 by doing it myself, and maybe more. I say that because the motor for this slide is larger than the other (*more expensive*) and because there may have been extra labor involved due to the corrosion problems. I hope this document comes in handy in case you ever have to deal with the same problem.
