## Removing the Onan 7500 From a Discovery Without a Generator Slide

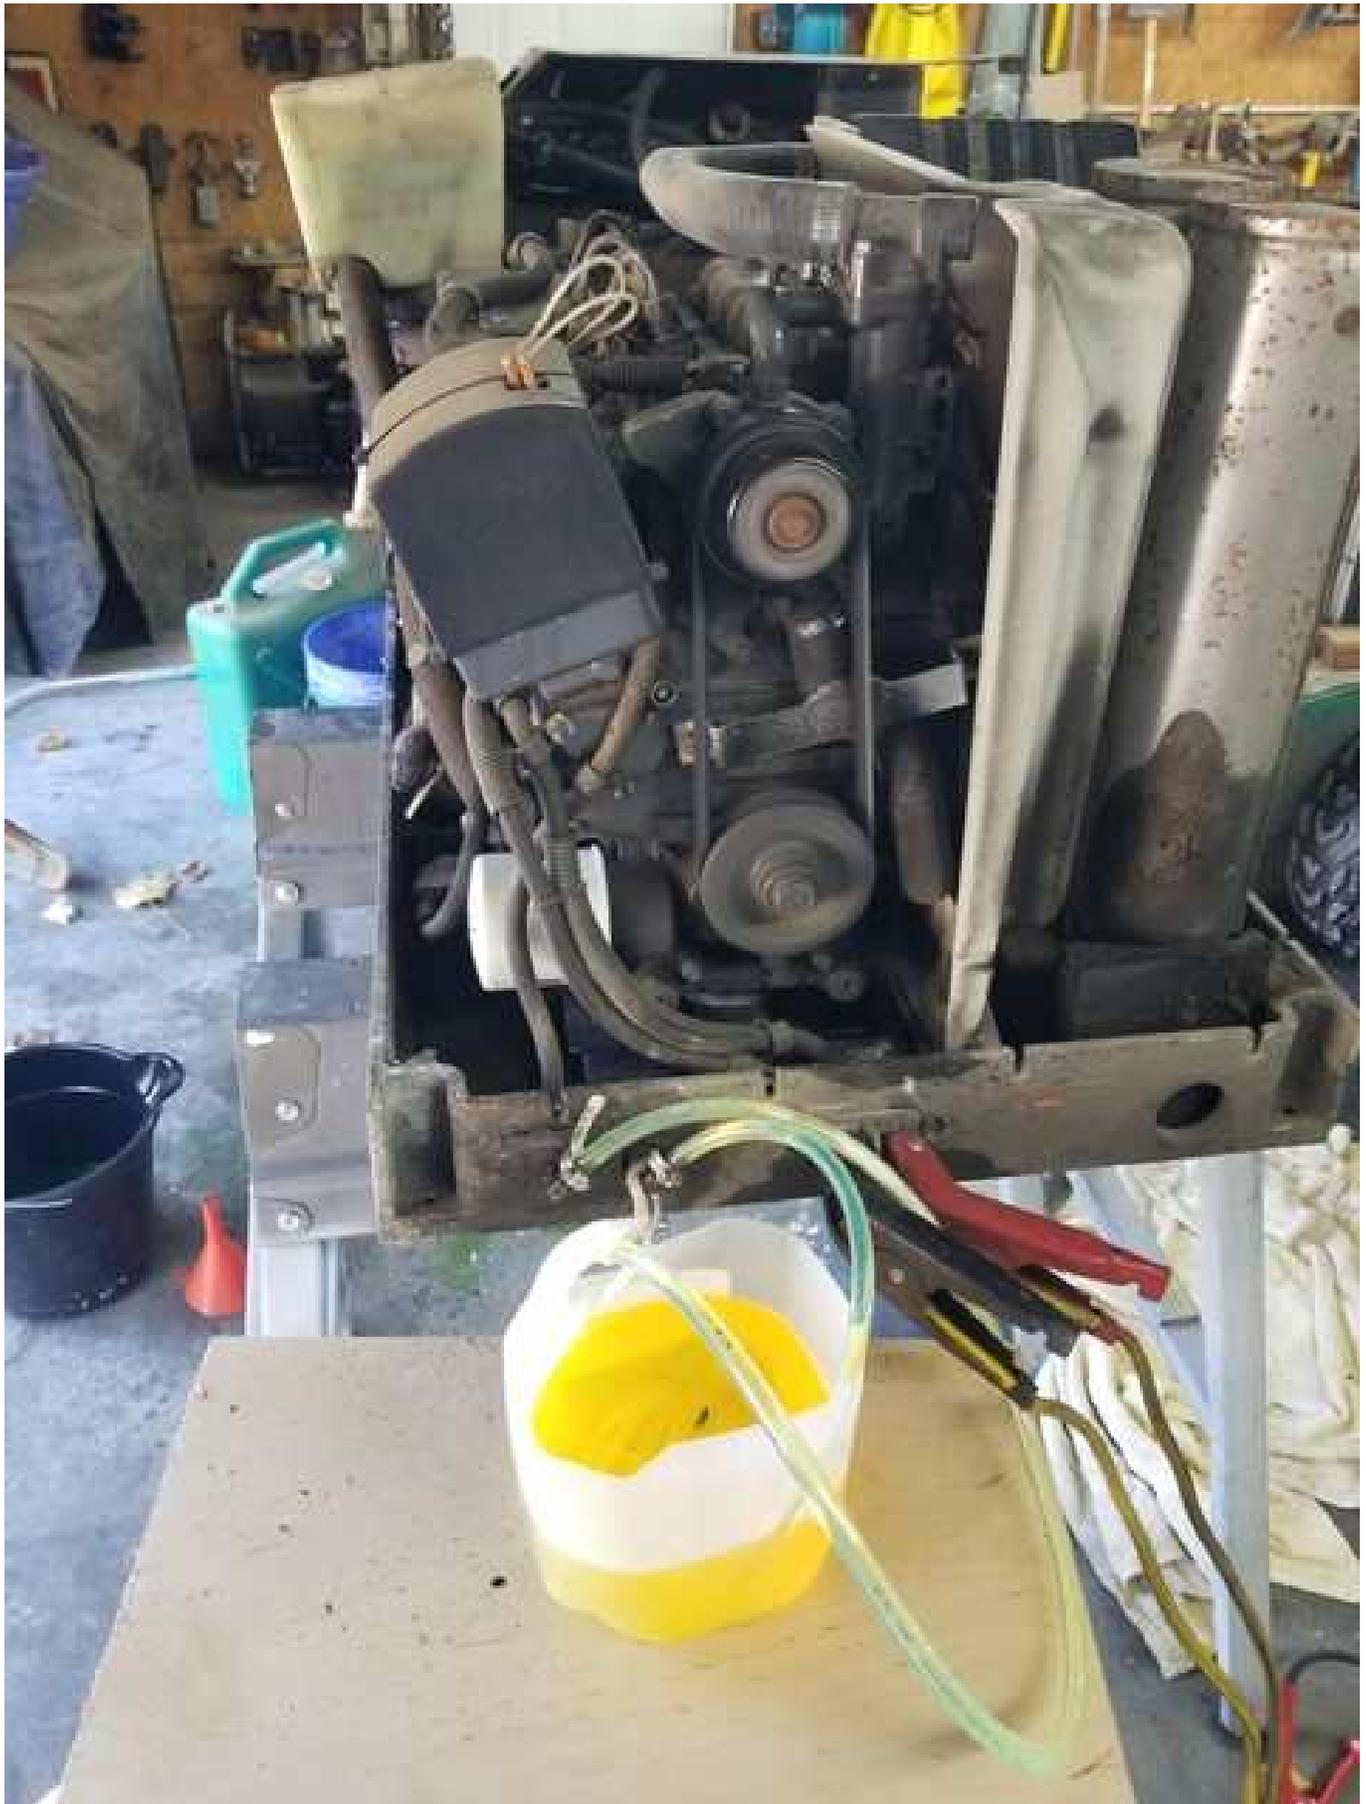
New belt installed and test running on bench with fuel lines in milk jug

- 5. Test run it on the bench:** I decided it was best to run it before reinstalling in the D. I used the bottom half of a milk jug with diesel fuel in it and put both fuel lines below the fuel level. Ran a set of jumper cables from my pickup battery, PRIMED it, and it started right up. I ran it for 15 minutes, at idle. I had no way to "load" the engine. But with the failed temperature sensor it would only run for 5 minutes (with no load) then shut down.

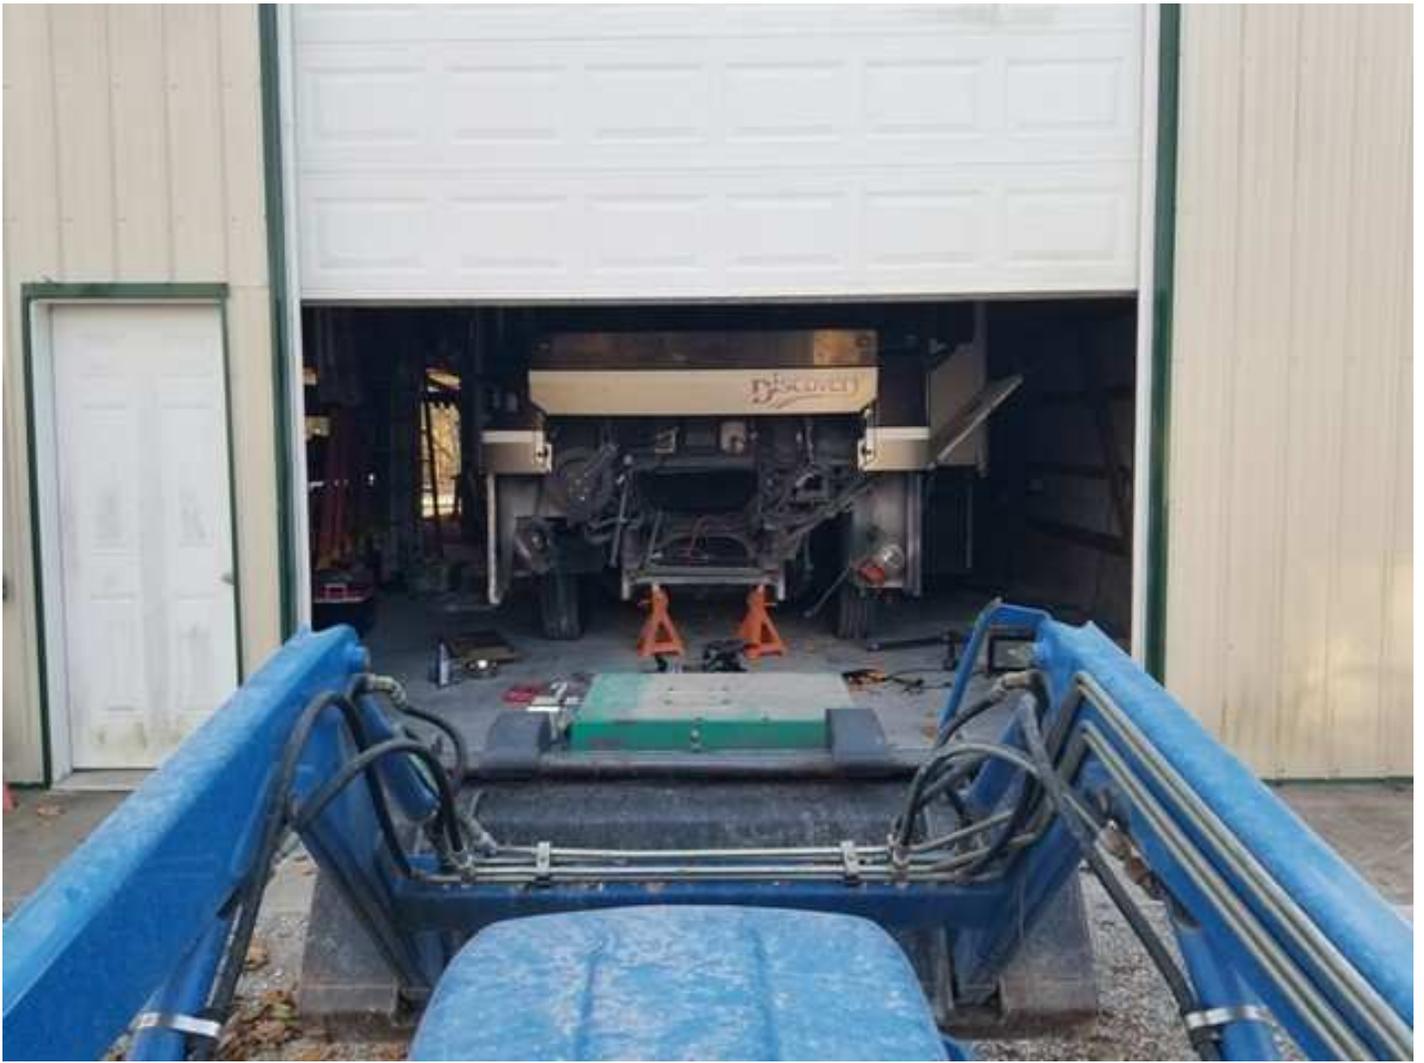
Carrying genny with tractor to reinstall

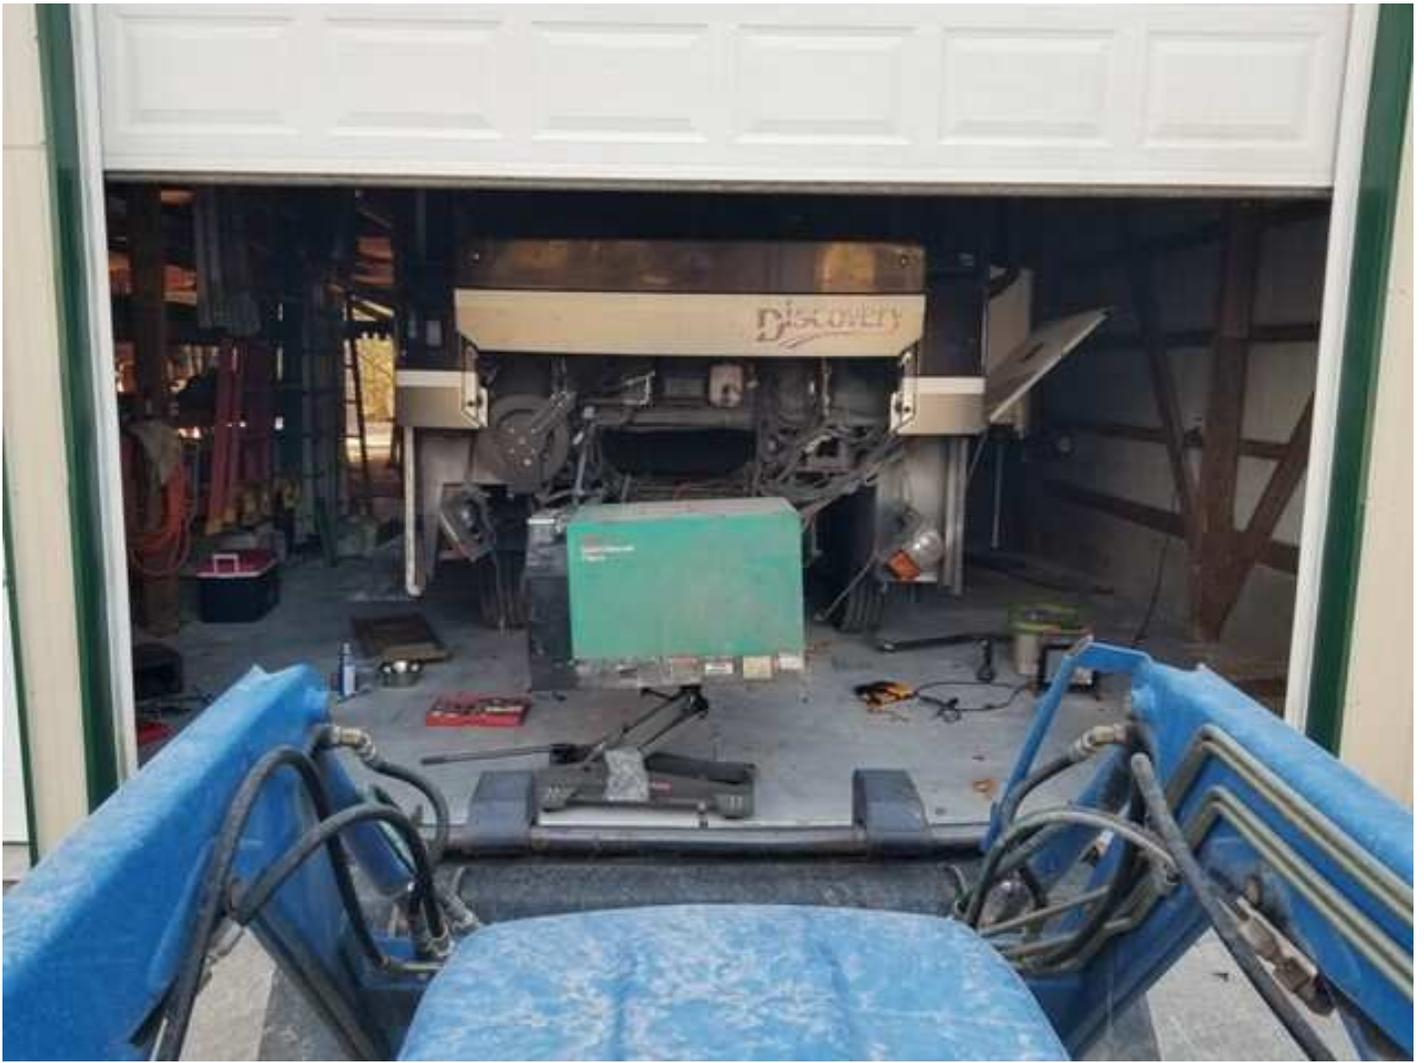
Genny on transmission jack ready to roll into place

- 6. Reinstall genny in D: Just reversed the process.** Lifted in place with transmission jack and bolted in. My buddy noticed the entire genny seemed to be "twisted" and we discovered one of the cradles had been bent so I had to remove it and straighten it. I replaced all the 1/4 bolts with stainless steel. I will mention the terminal block which connects the AC wires from the generator fields to the cables going to the BCC, was quite rusty and I had to soak them with PB Blaster for a couple of days. When I reinstalled it one of them stripped. I tapped it out to one size larger and made sure to put anti oxidant grease on all connections. I then test ran it at 50 amps, about 6,000 watts (1500 watt space heater, microwave, air fryer, and water heater) for 15 minutes and declared success.

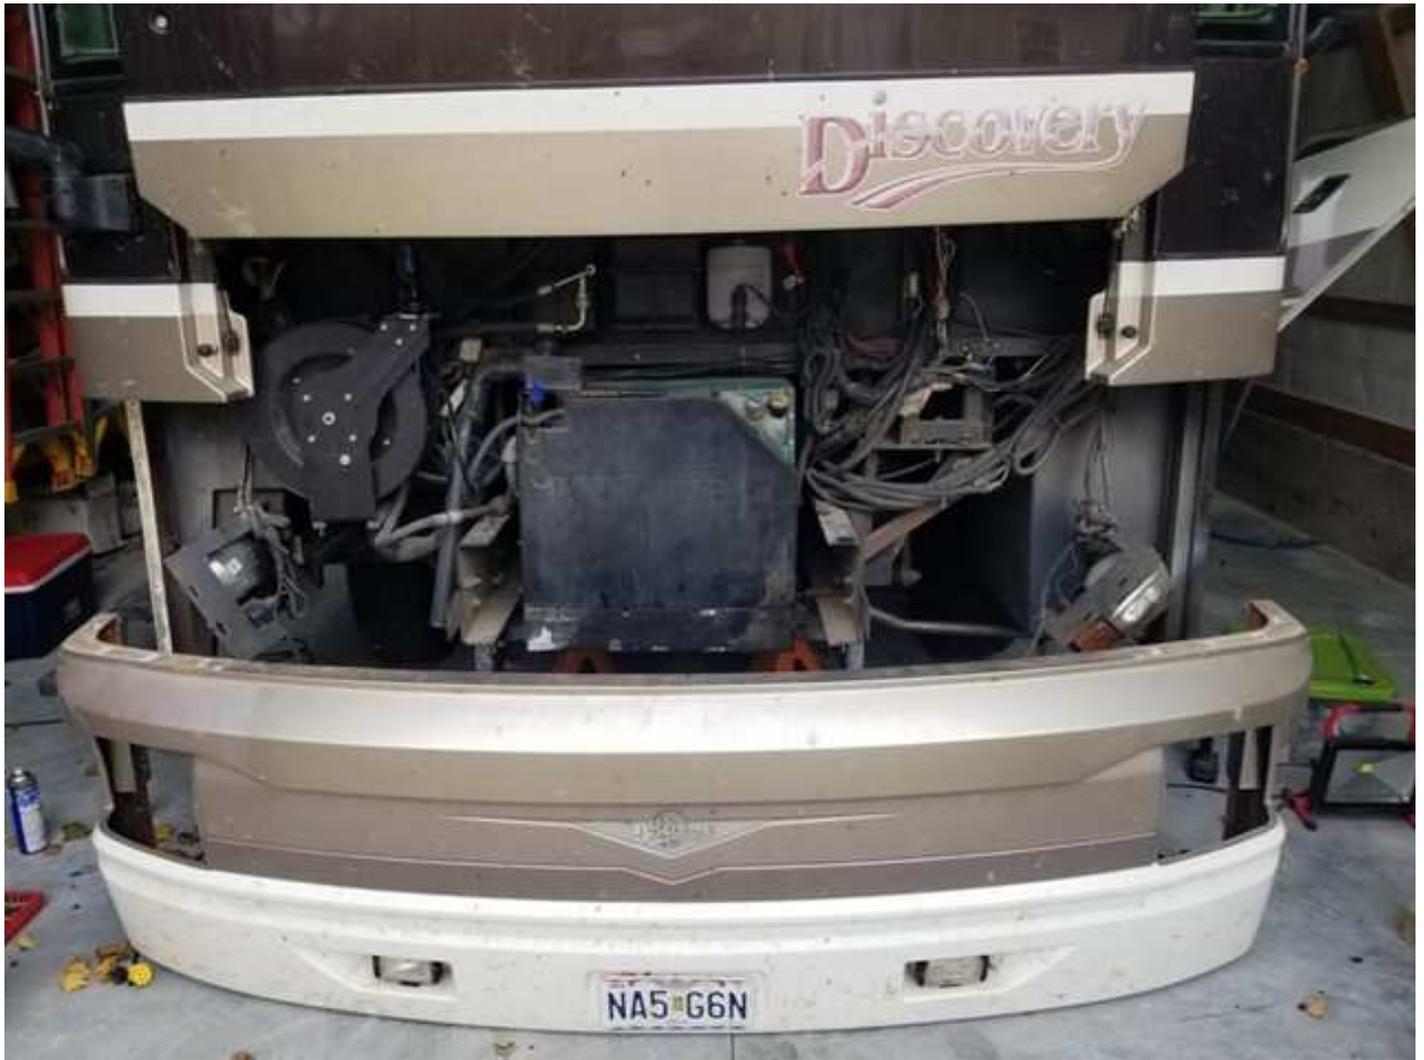
Genny bolted in and ready to lift front cap into place
